Special Investigation Report
Aircraft Separation Incidents at Hartsfield
Atlanta International Airport, Atlanta, Georgia
October 7, 1980

SPECIAL INVESTIGATION REPORT

**AIRCRAFT SEPARATION INCIDENTS
AT HARTSFIELD ATLANTA INTERNATIONAL AIRPORT
ATLANTA, GEORGIA
OCTOBER 7, 1980**

NTSB-SIR-81-6

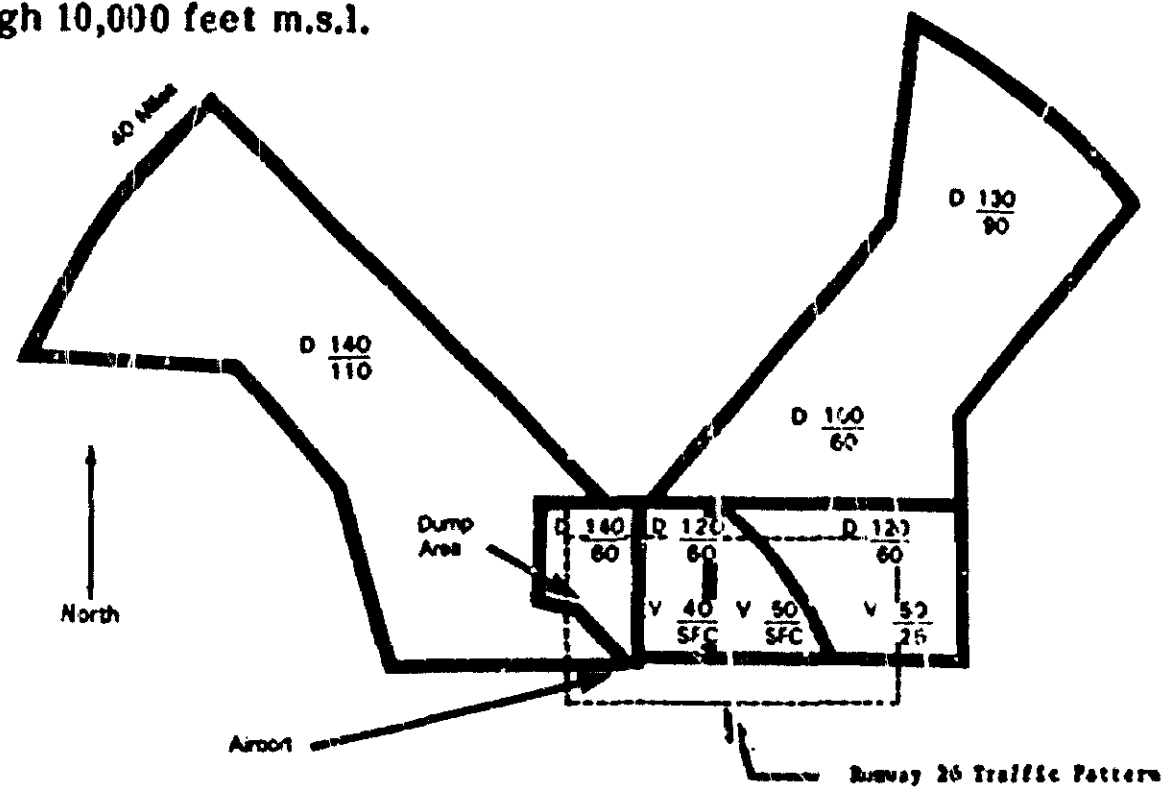
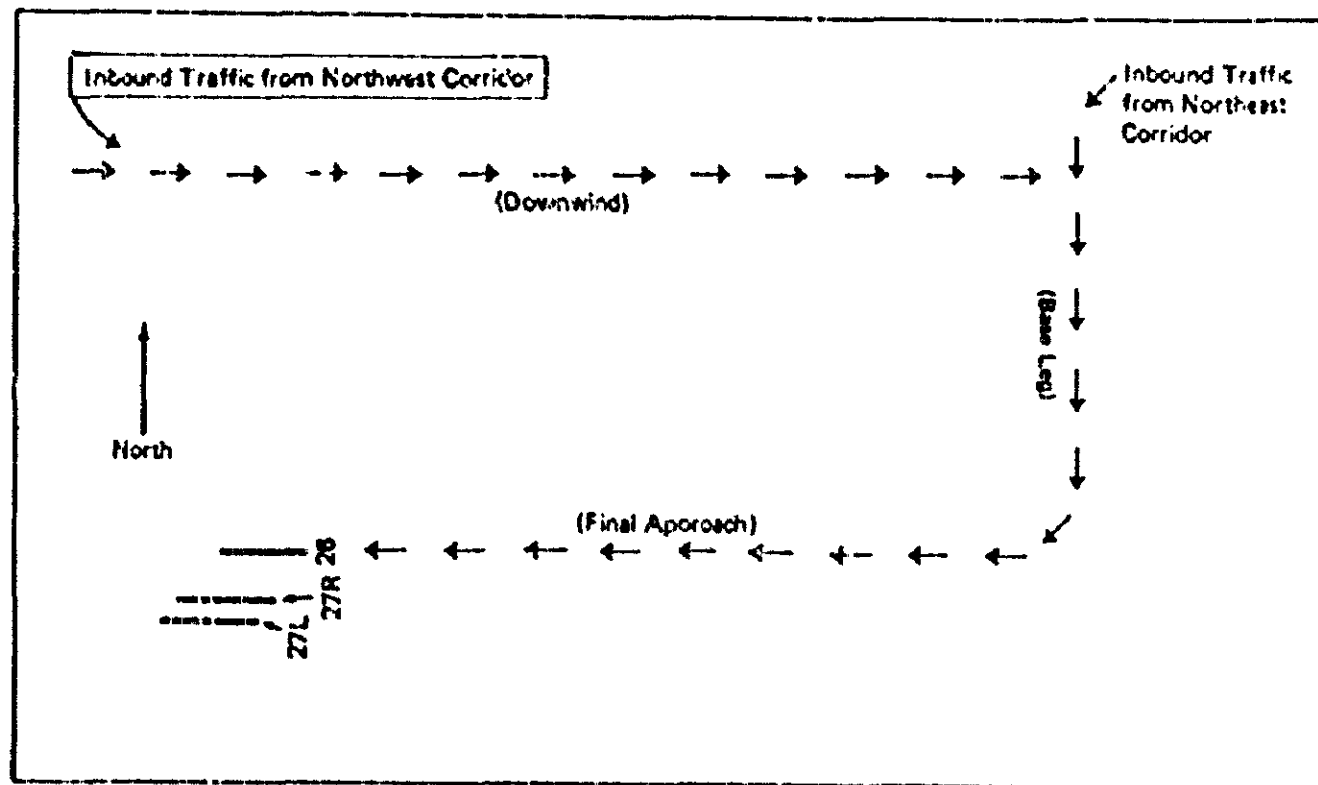
Figure 1.--Boundaries of responsibility of north feeder controller and final controller.

The north terminal arrival (feeder) controller is responsible for the airspace designated "D" and the airspace for which the north final controller (final) is responsible is designated "V." D 100 means the feeder controller is responsible for the control of all traffic from 6,000 through ⁶⁰10,000 feet m.s.l.

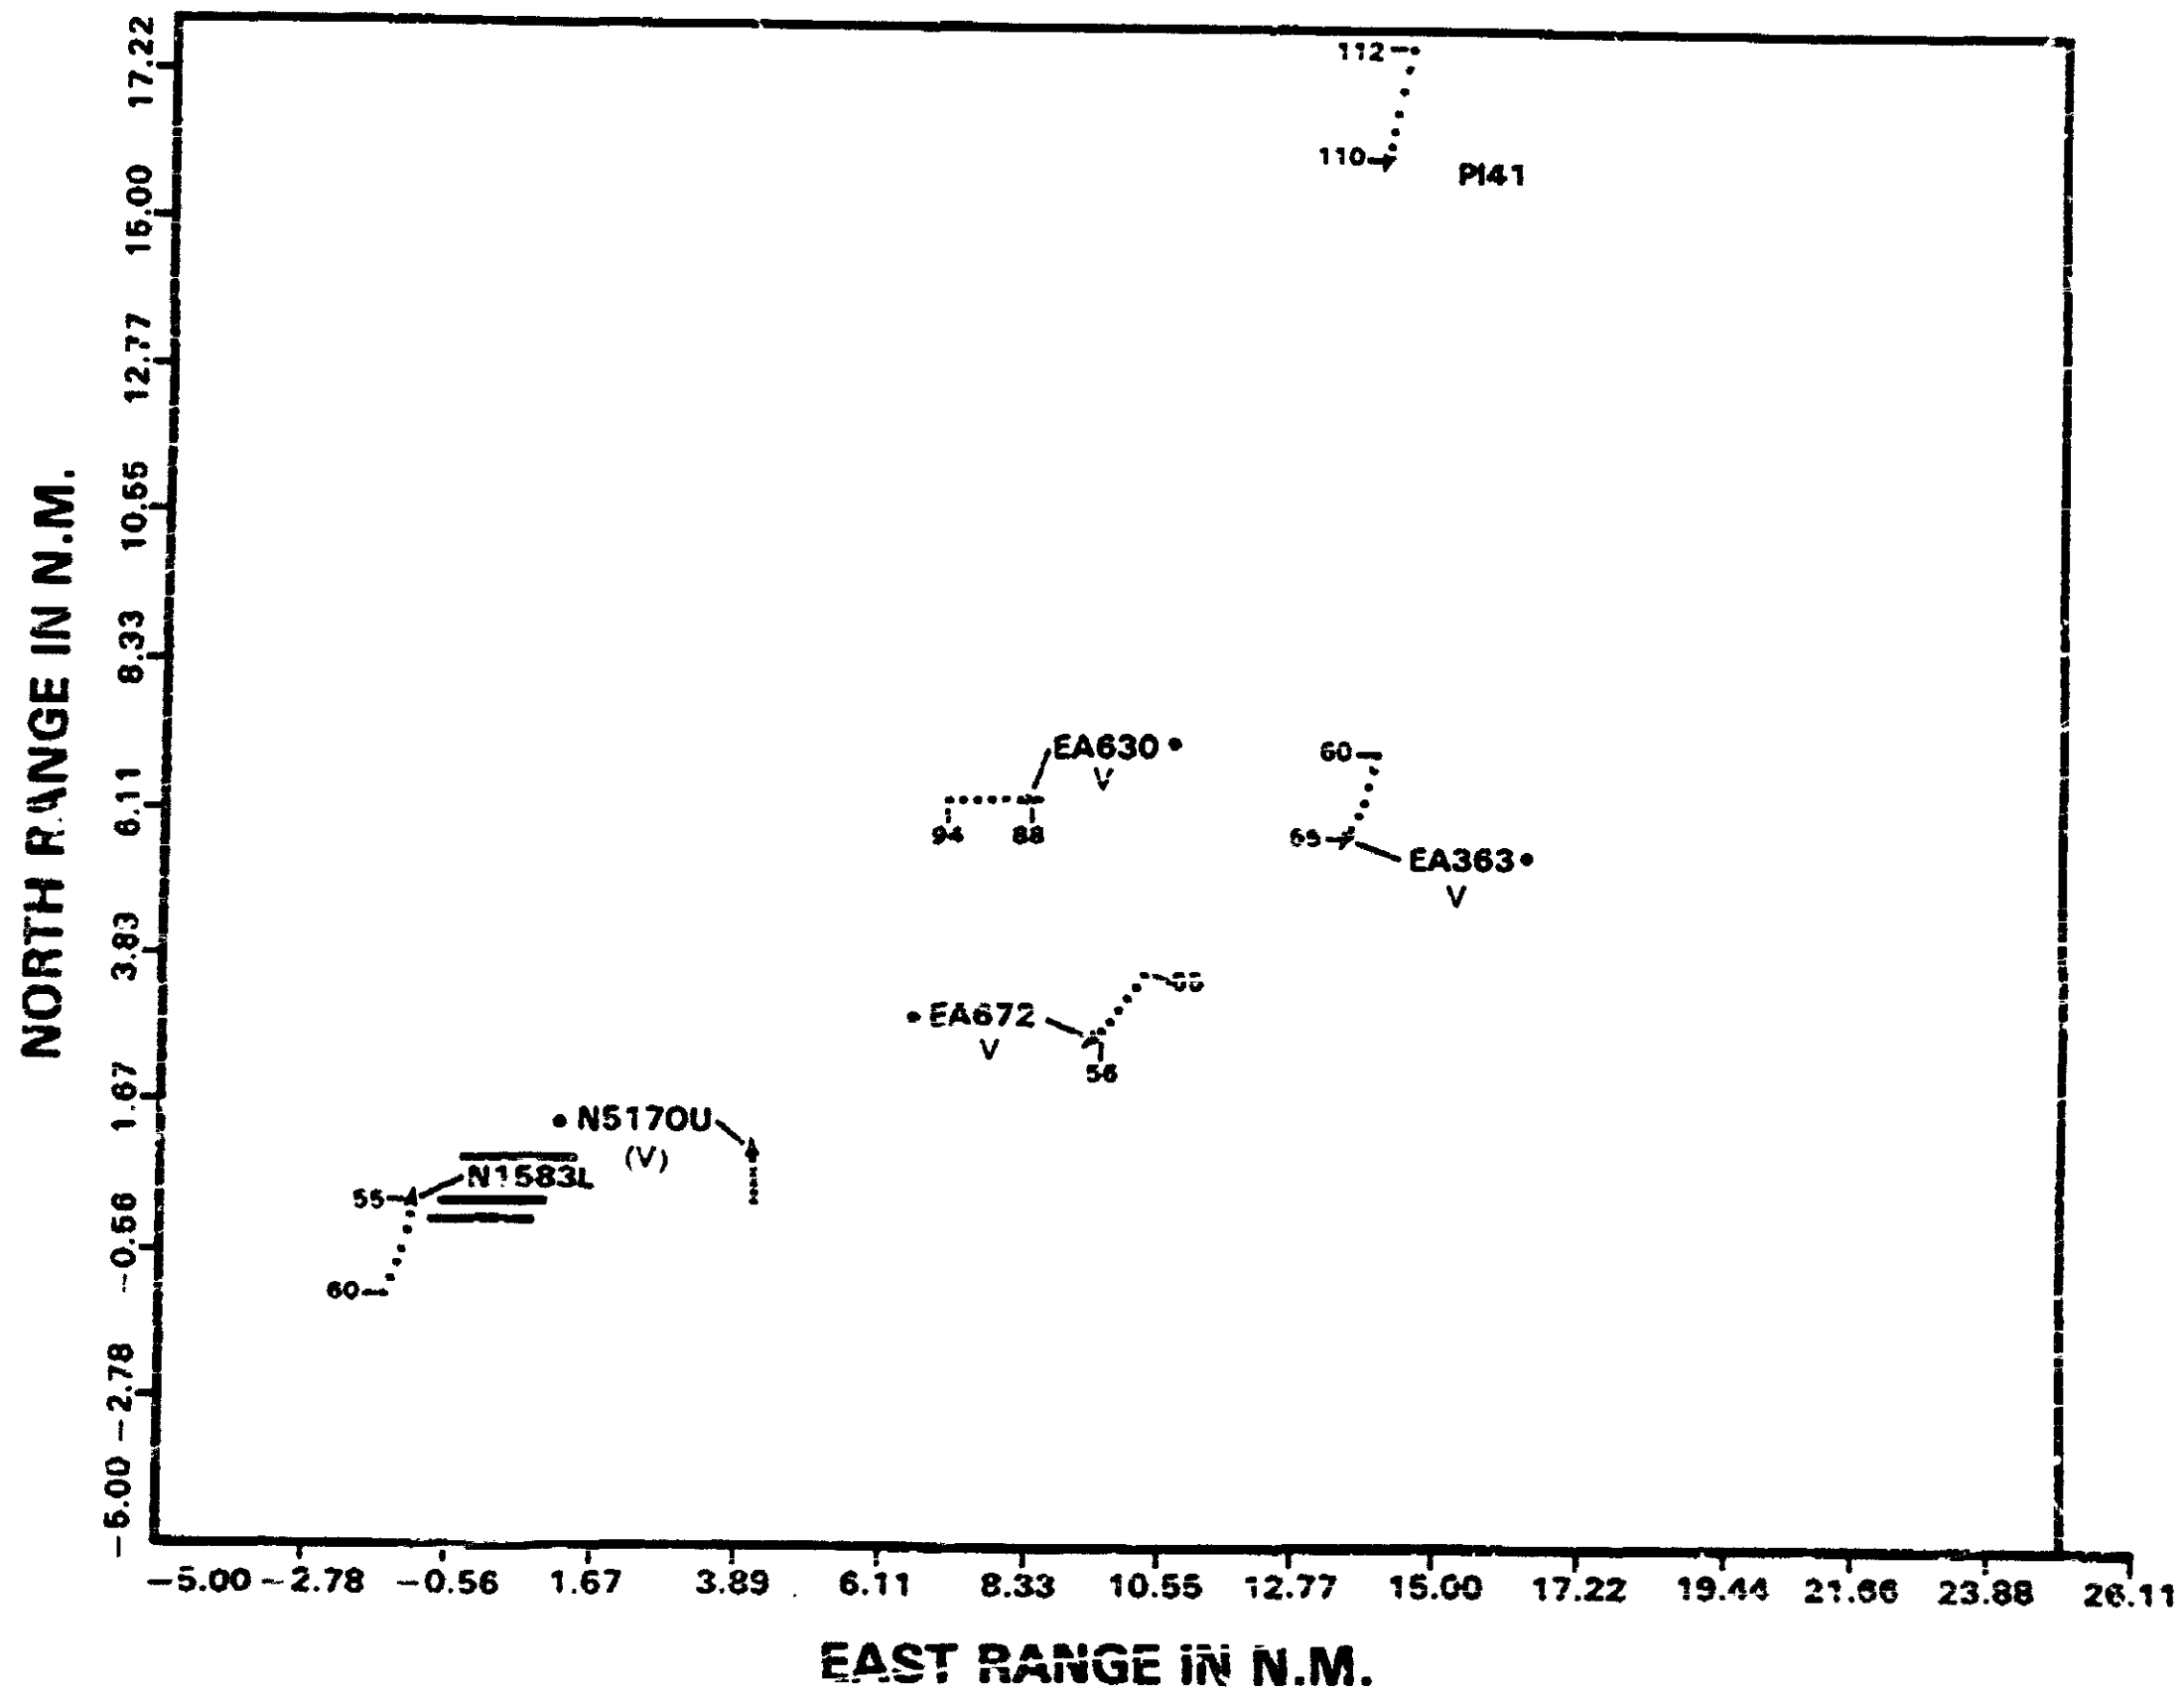
08:09:30.0-08:10:00.0

Note that the final controller cleared EA363 for a visual approach, and then pointed out the traffic. Visual approach should be used only after "the succeeding aircraft reports sighting the preceding aircraft." (ATC 7110.65A, paragraph 790.)

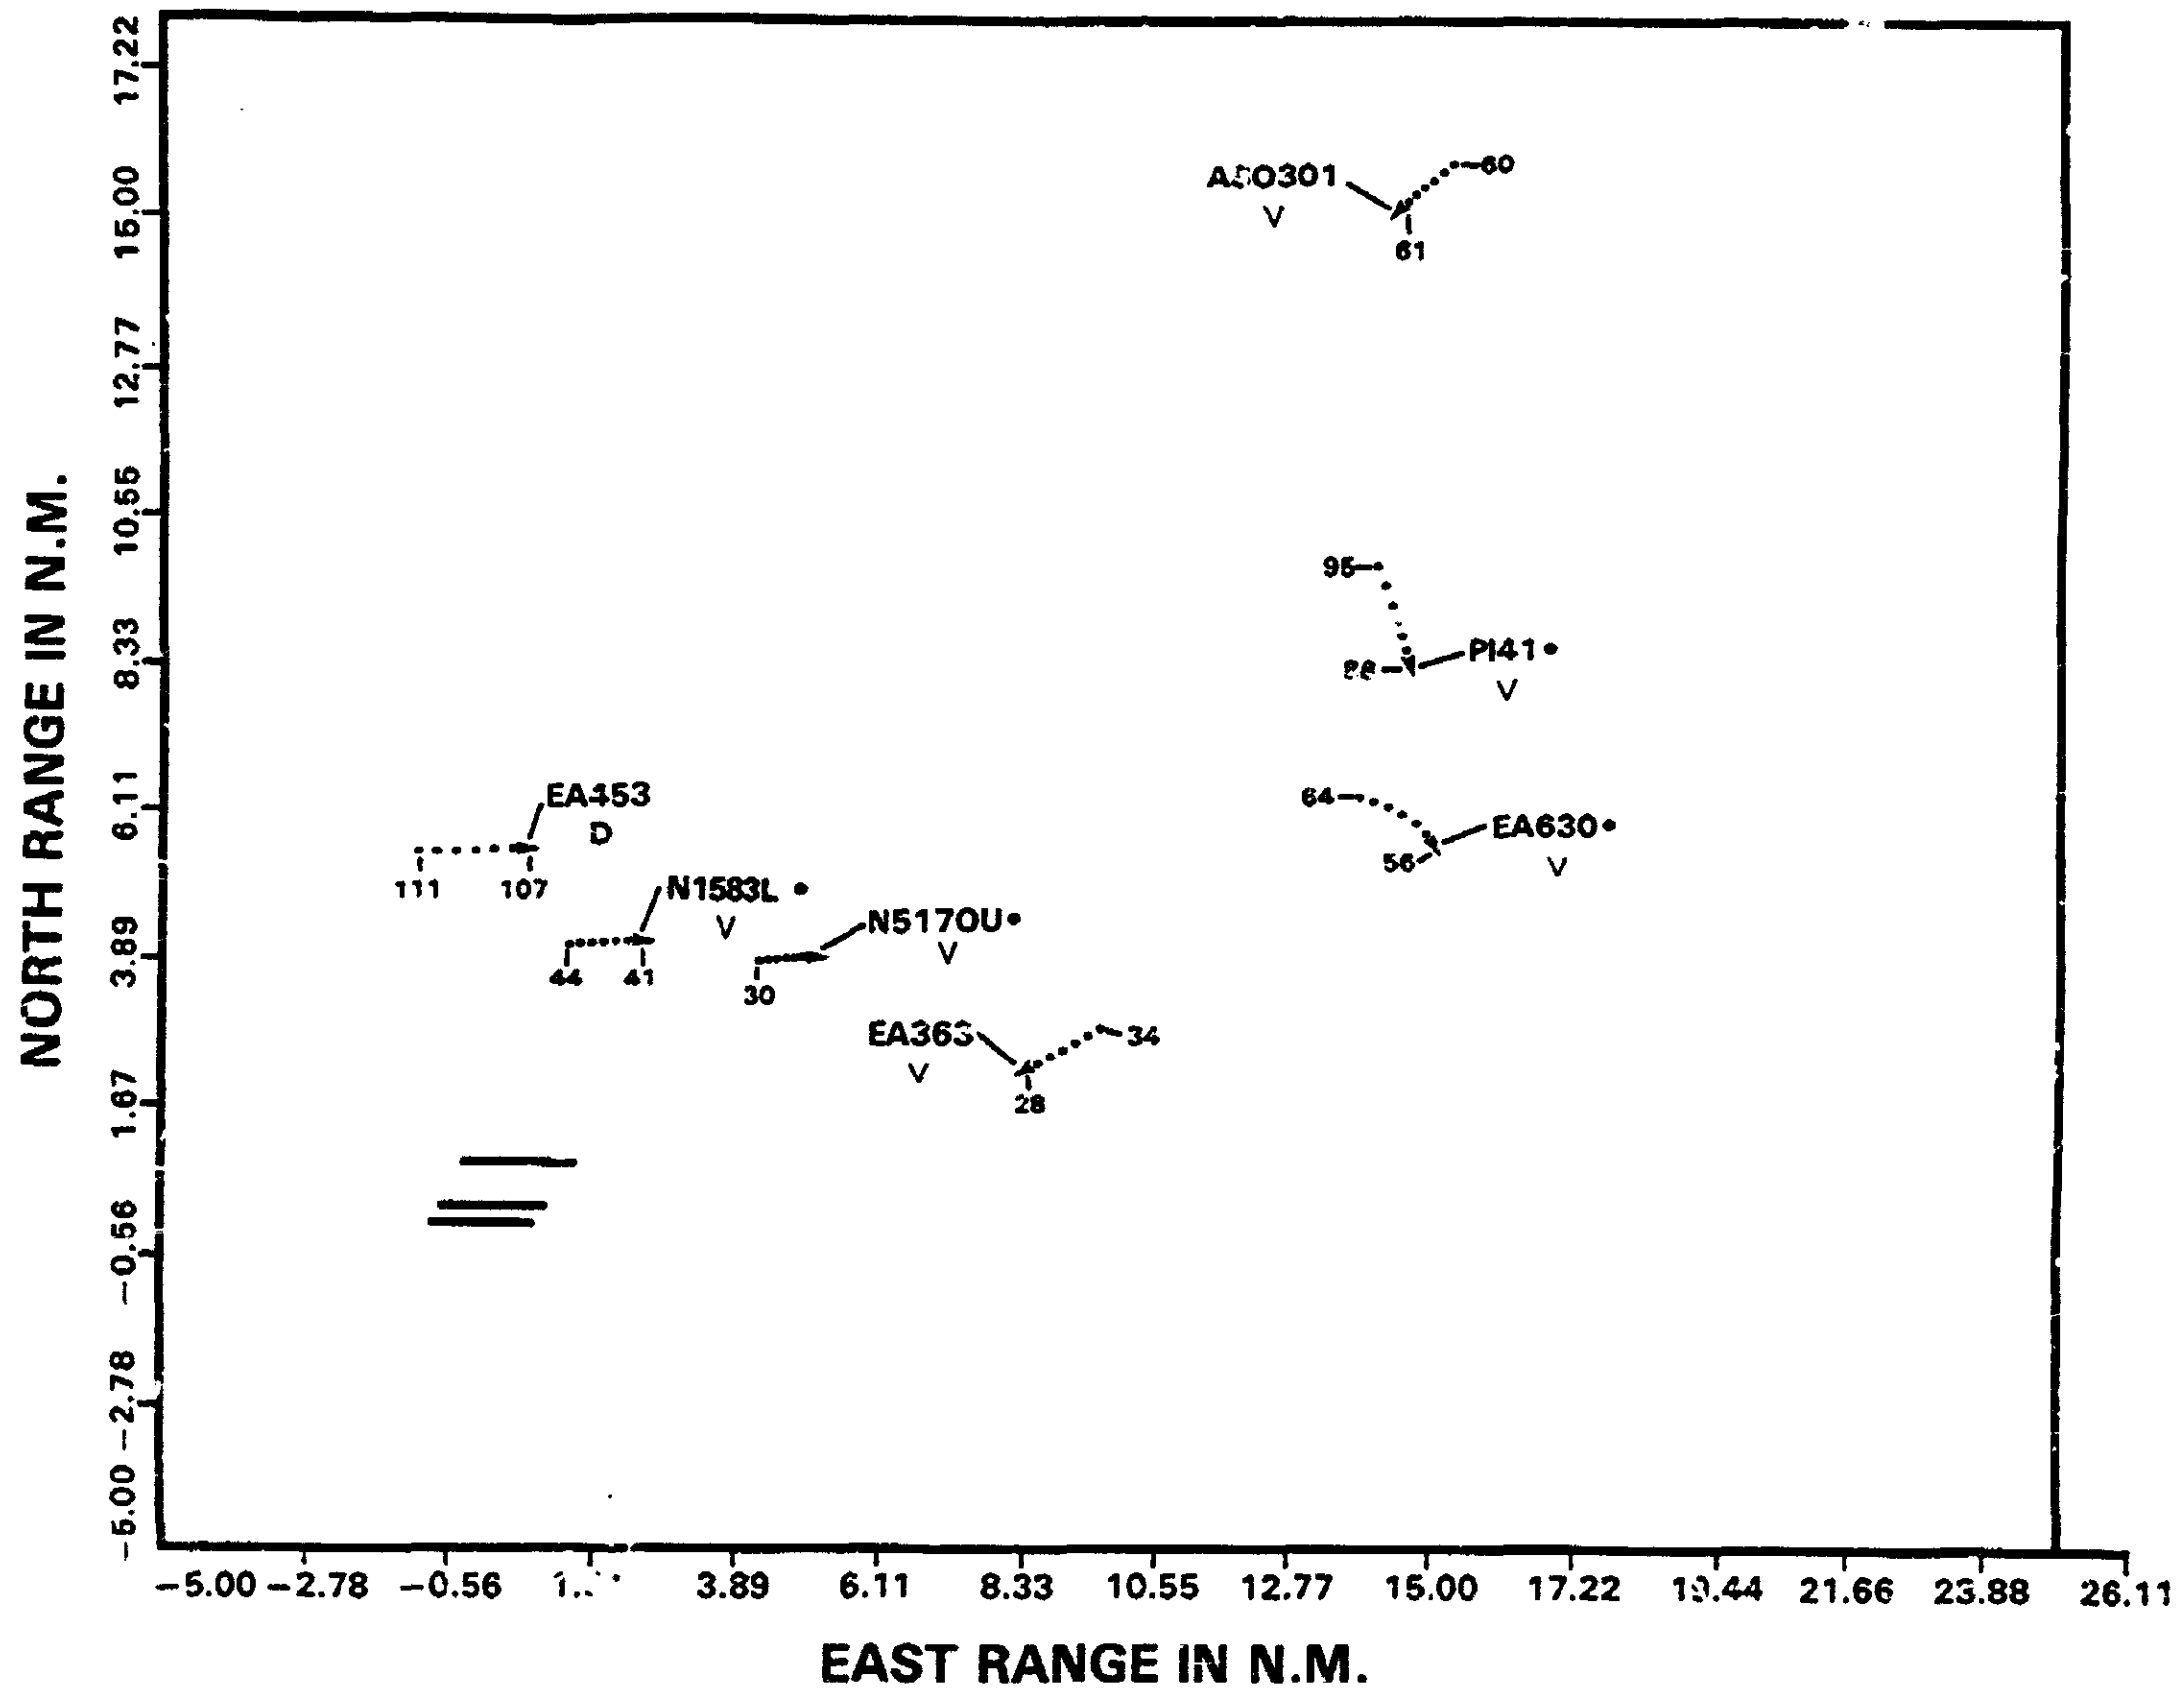
08:11:30.0-08:12:00.0

The flightpath of N5170U should be noted. The final controller has assigned a heading of 090 to the aircraft, taking it away from the airport. In view of the relative speeds of the aircraft involved, this created an unwarranted increase in workload.

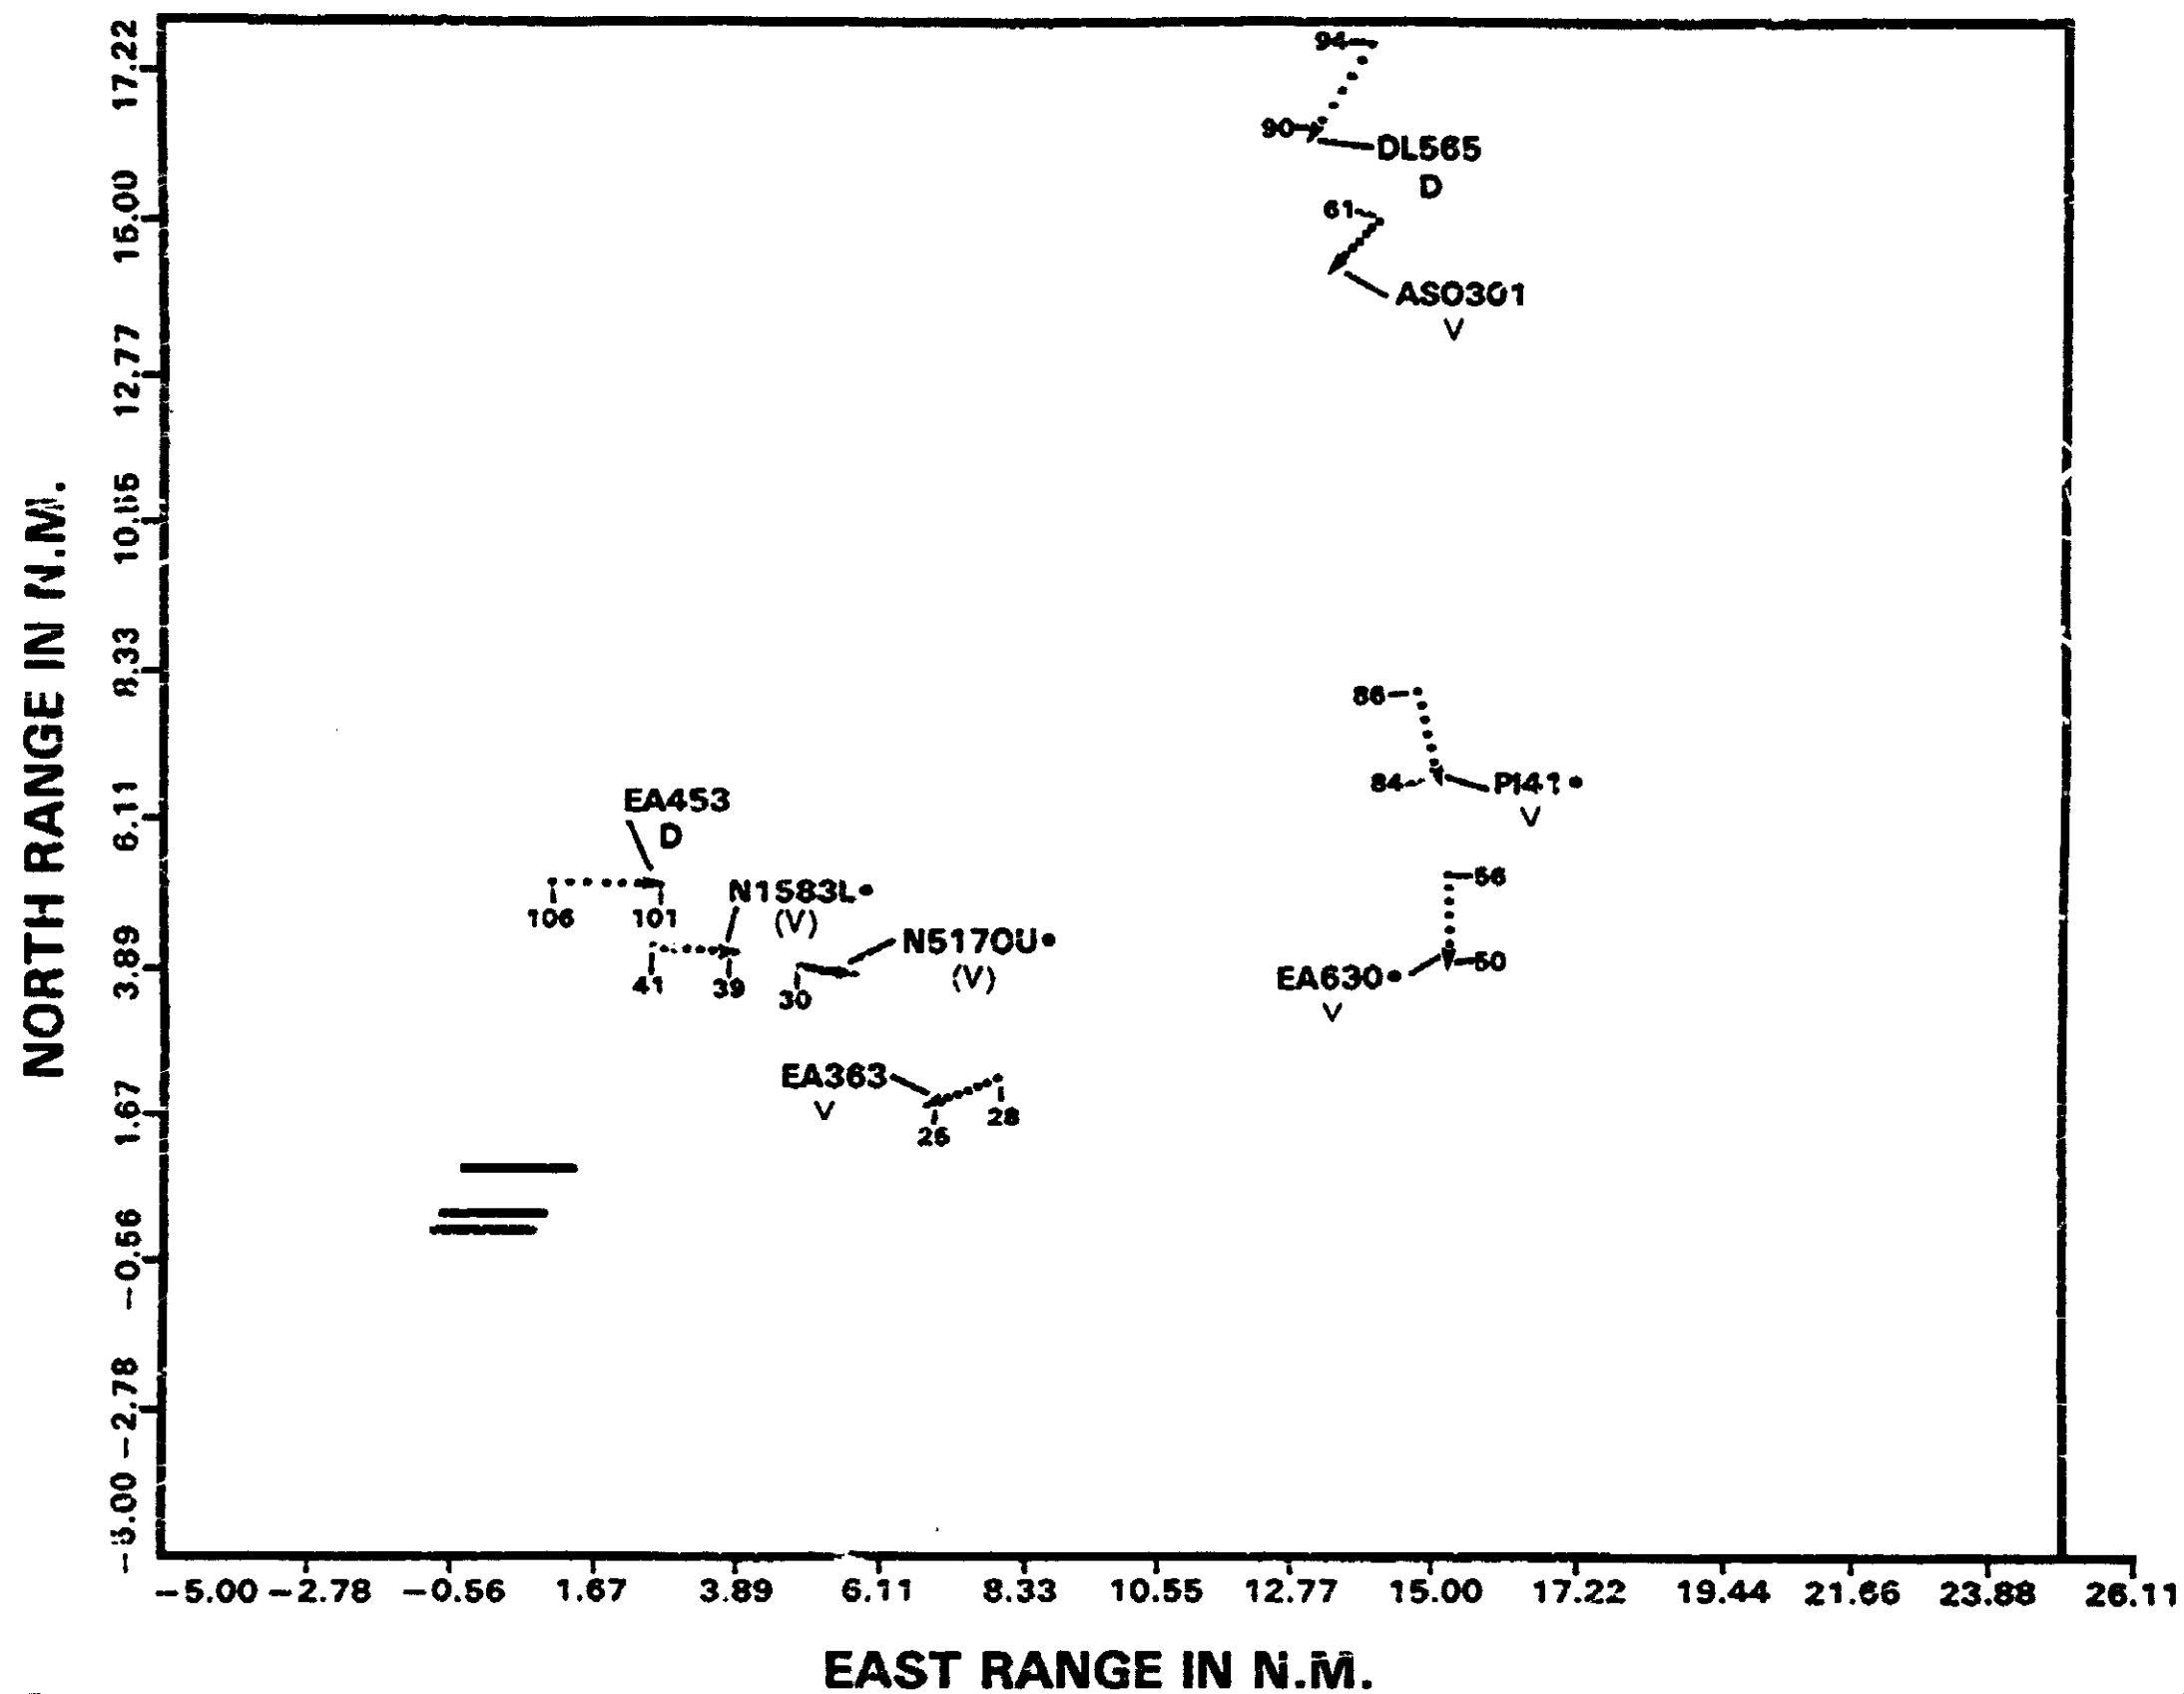
08:12:00.0-08:12:30.0

The feeder controller has assigned a heading
of 180 to DL565. Although flights are normally
transferred from the feeder controller to the
final controller descending to 6,000, DL565
was "stopped" at 7,000 because of ASO301
immediately ahead at 6,000.

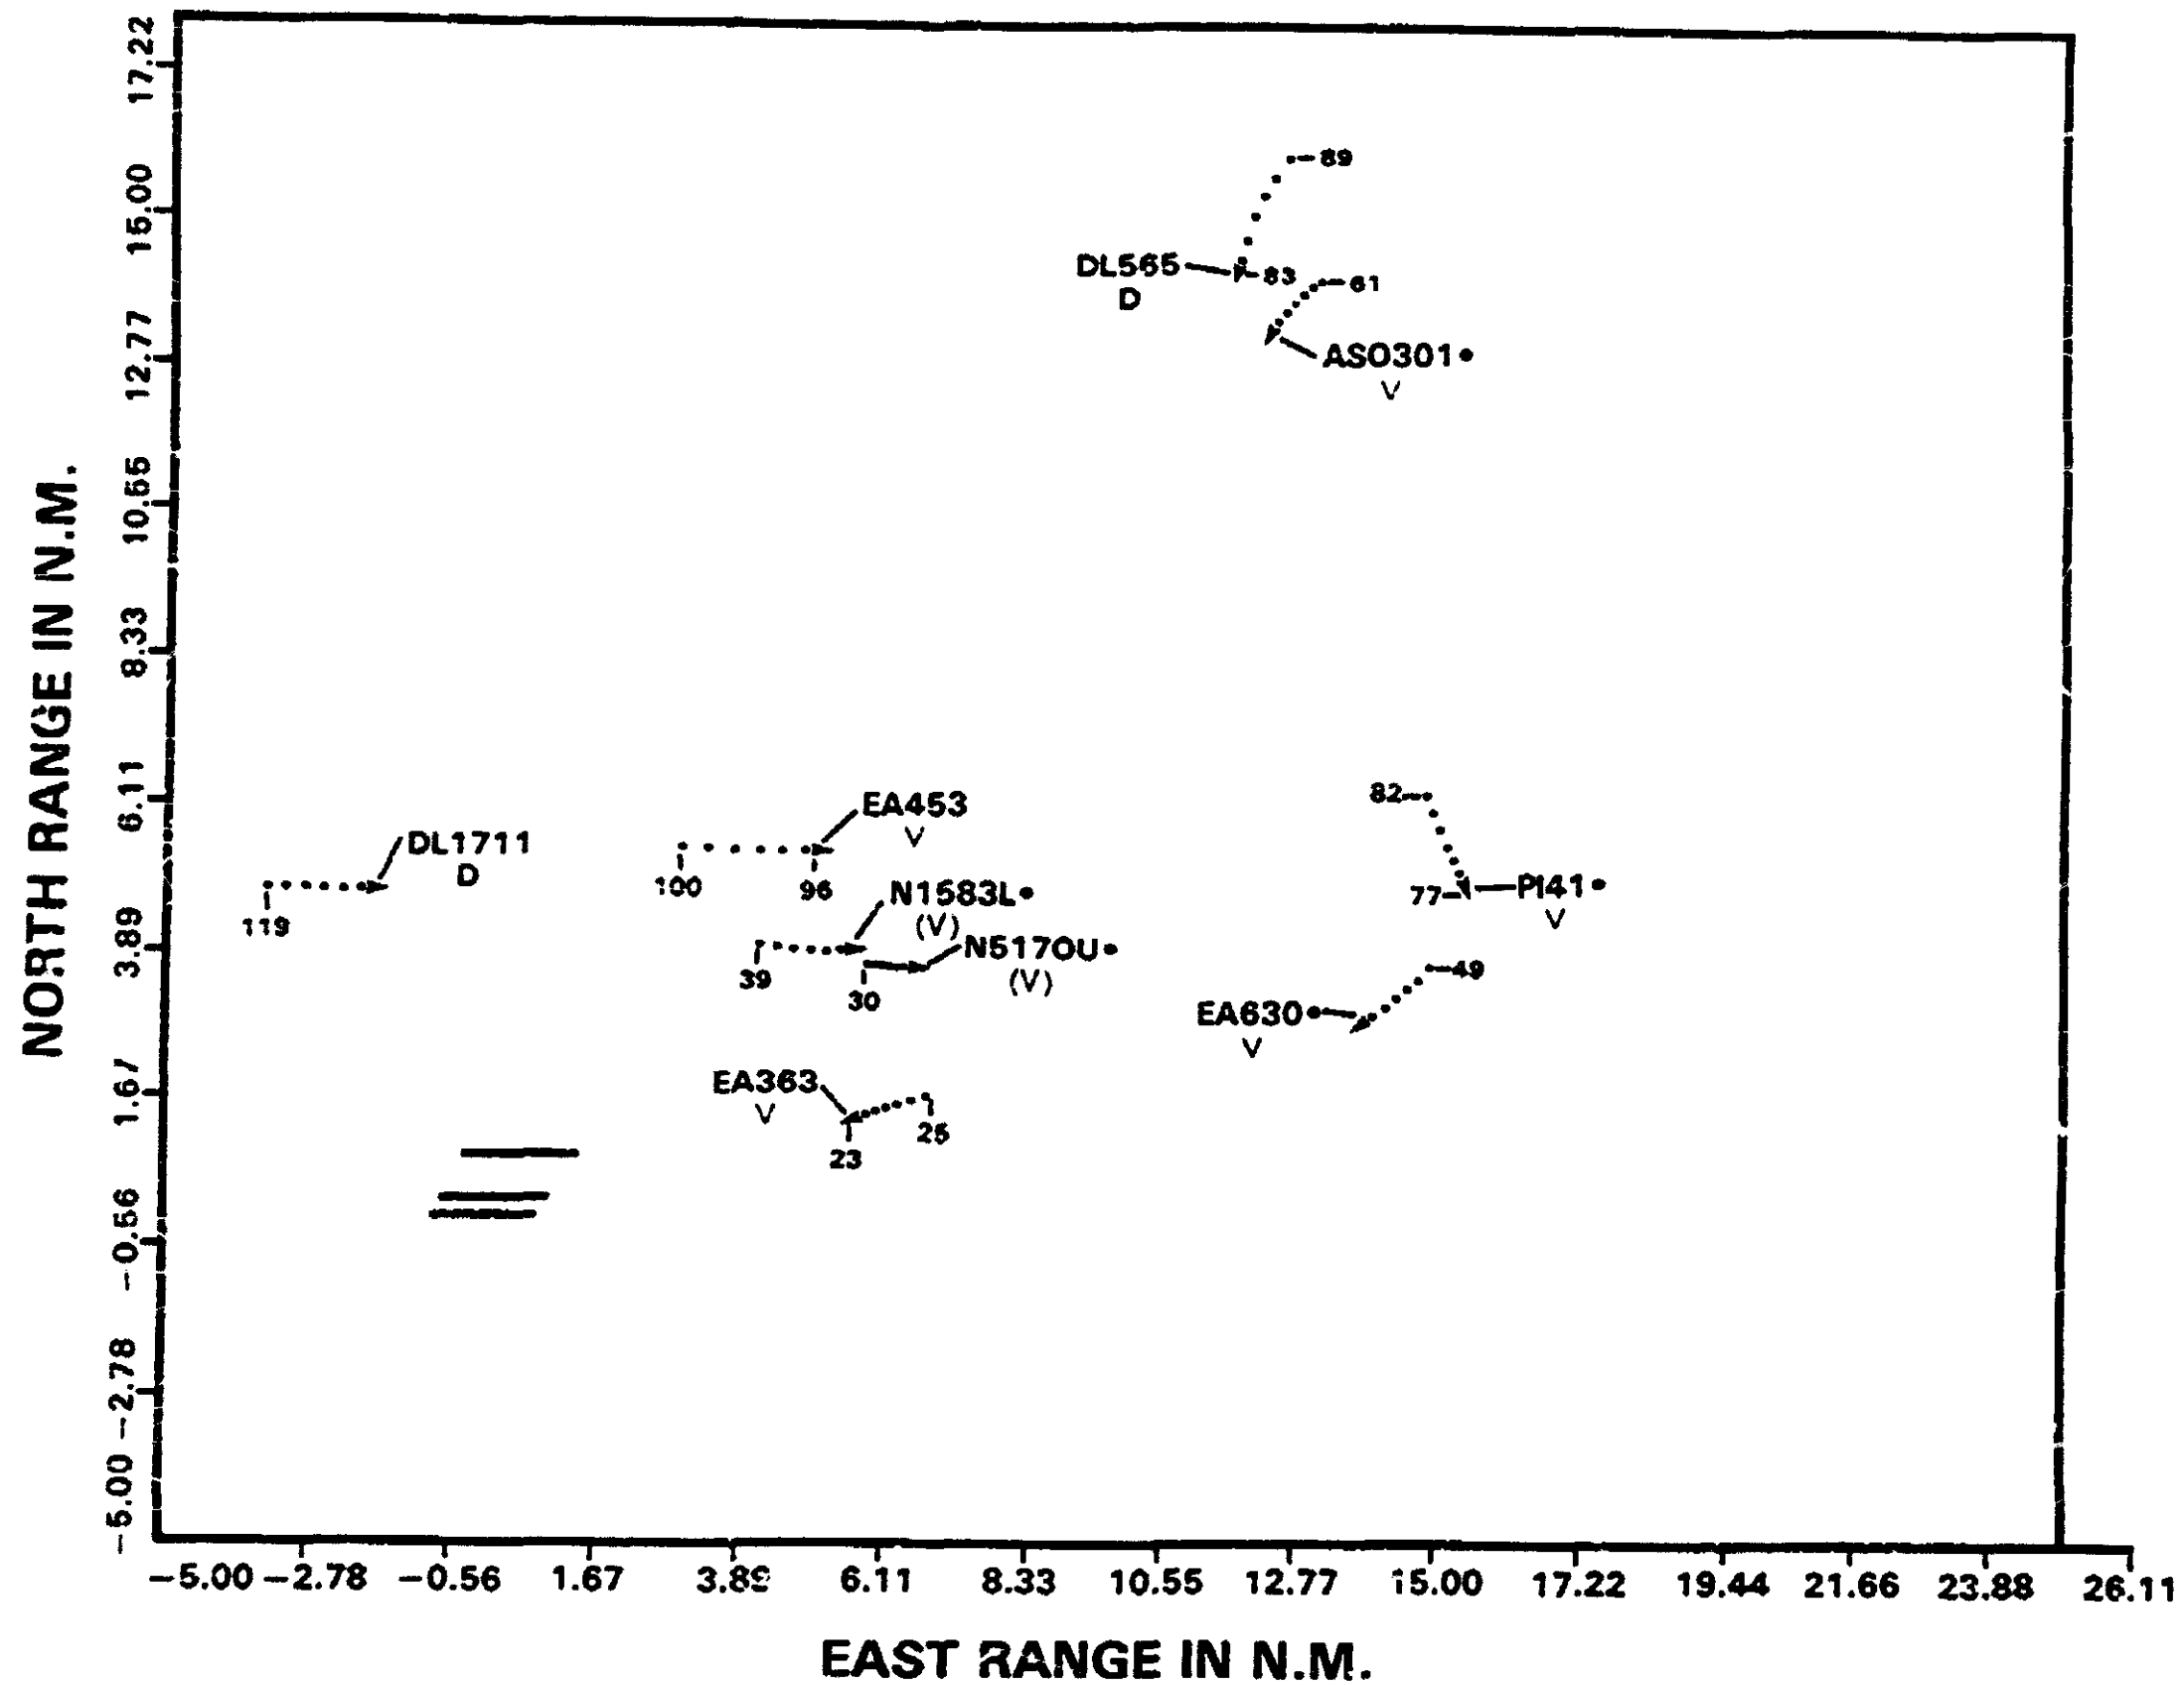
08:12:30.0-08:13:00.0

Note that N5170U had been instructed to turn in behind EA363 but 30 sec after the instruction was issued, the aircraft is still heading eastbound. This compounded the problem of sequencing N5170U with the traffic flow.

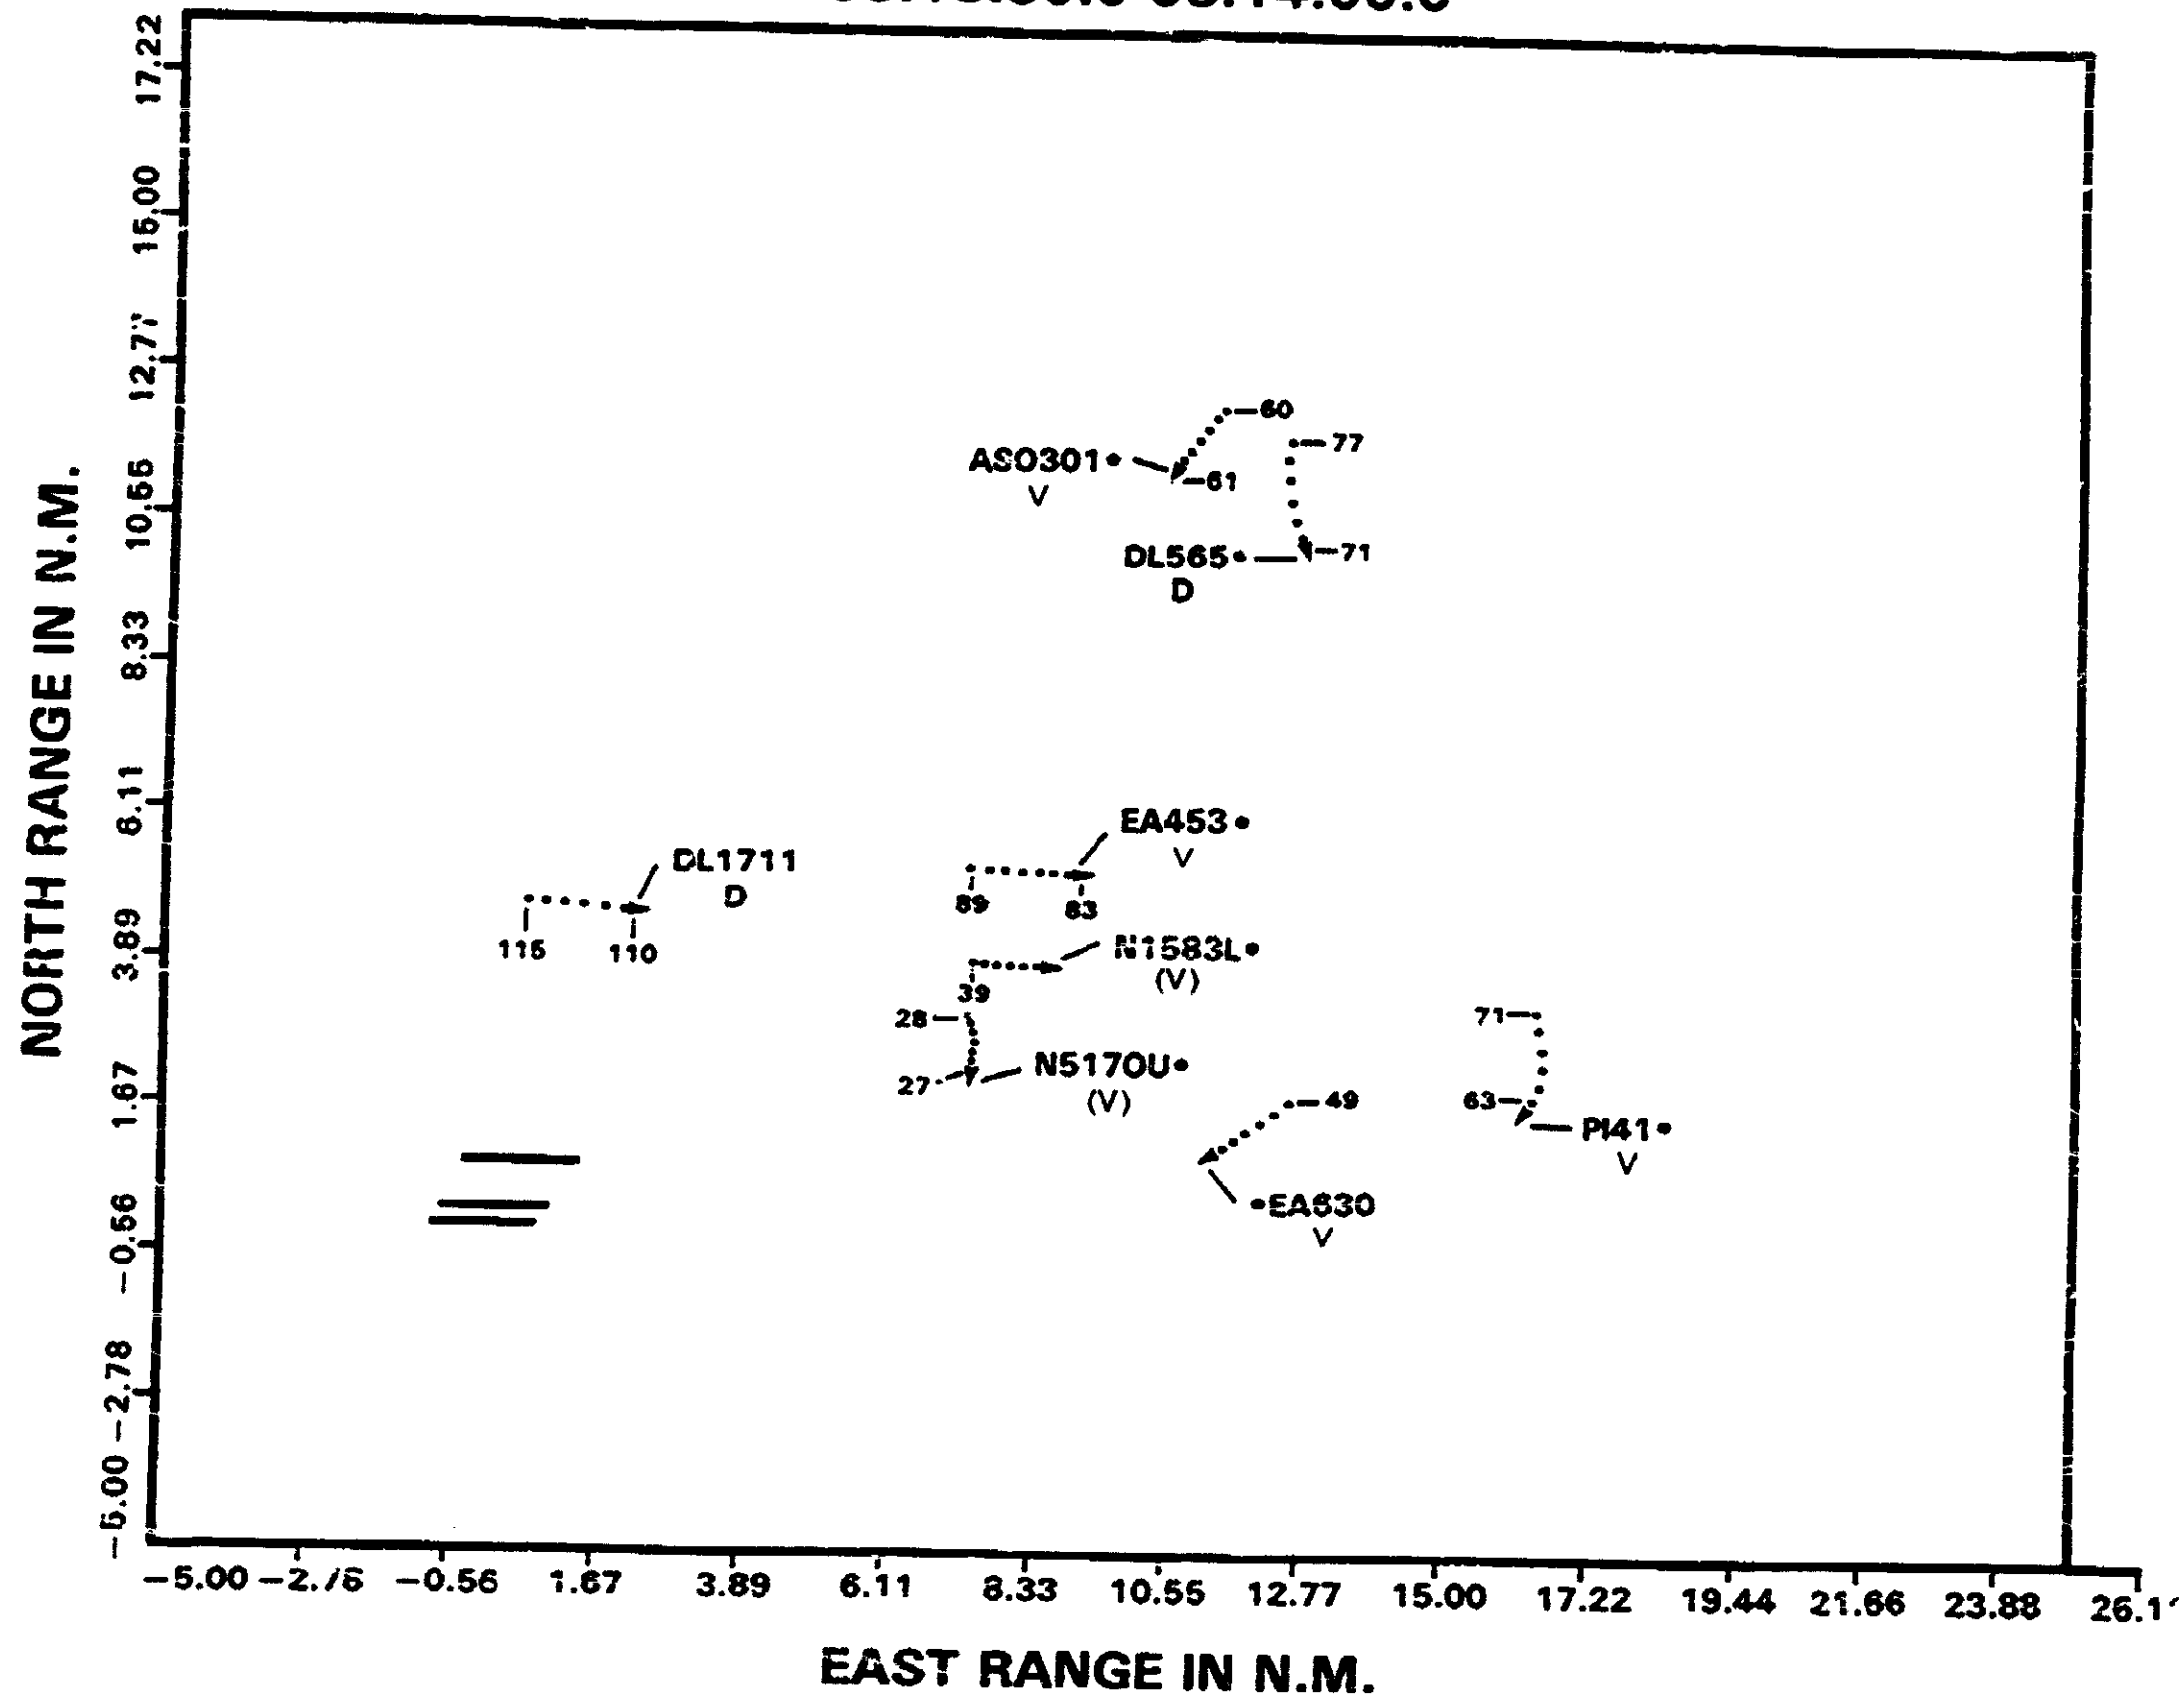
08:13:30.0-08:14:00.C

The visual approach clearance without pointing out preceding traffic should be noted.

EA630 is "catching" N5170U. This should definitely have been recognized at this point, and appropriate action taken.
